## **APPENDIXES**

This Appendix contains prints of digital images depicting natural and cultural aspects of the project area on Kelleys Island, Ohio. The Appendix is subdivided into 4 sections which comprise the following topics:

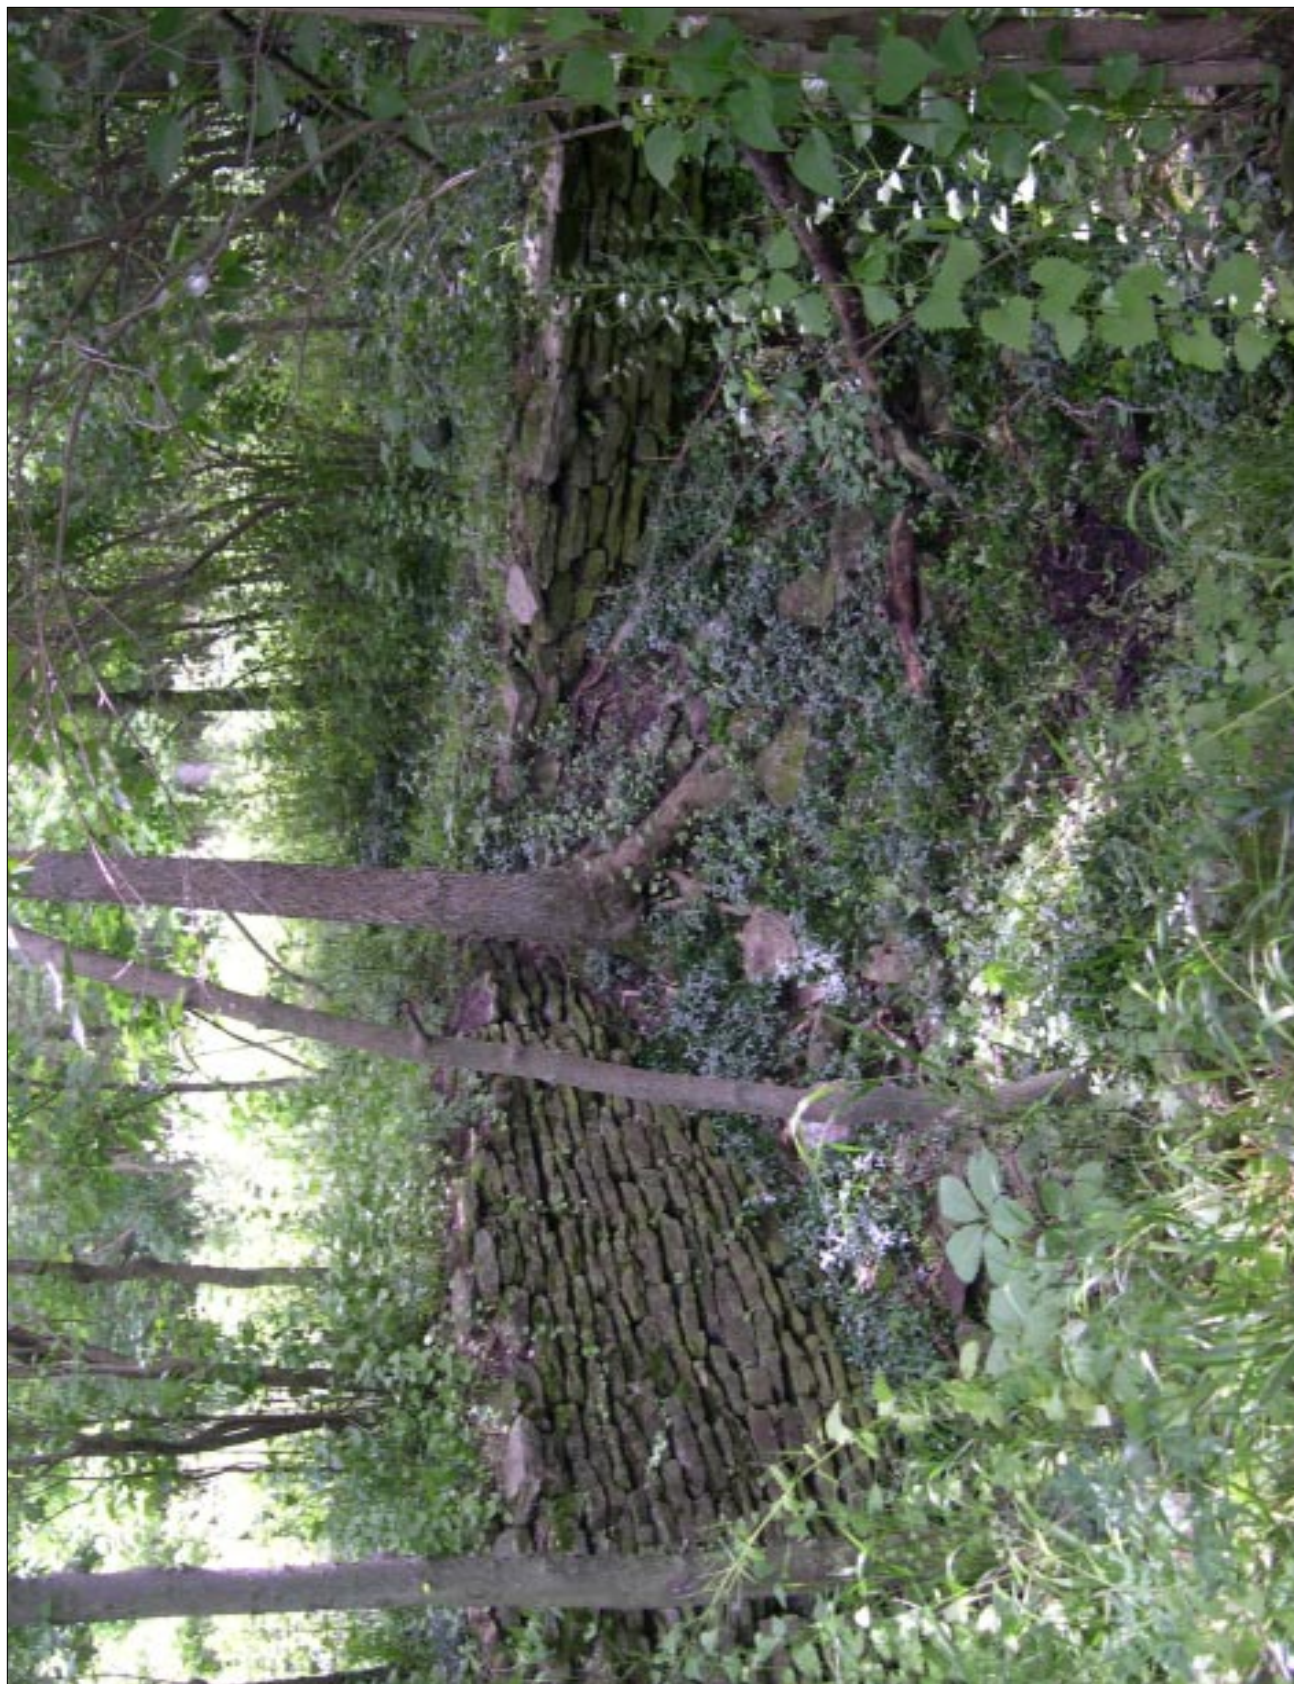
*Image LH-8. Lincoln House cellar, showing fill debris and 0.2 m diameter hackberry tree growing on floor (May 29, 2004).*

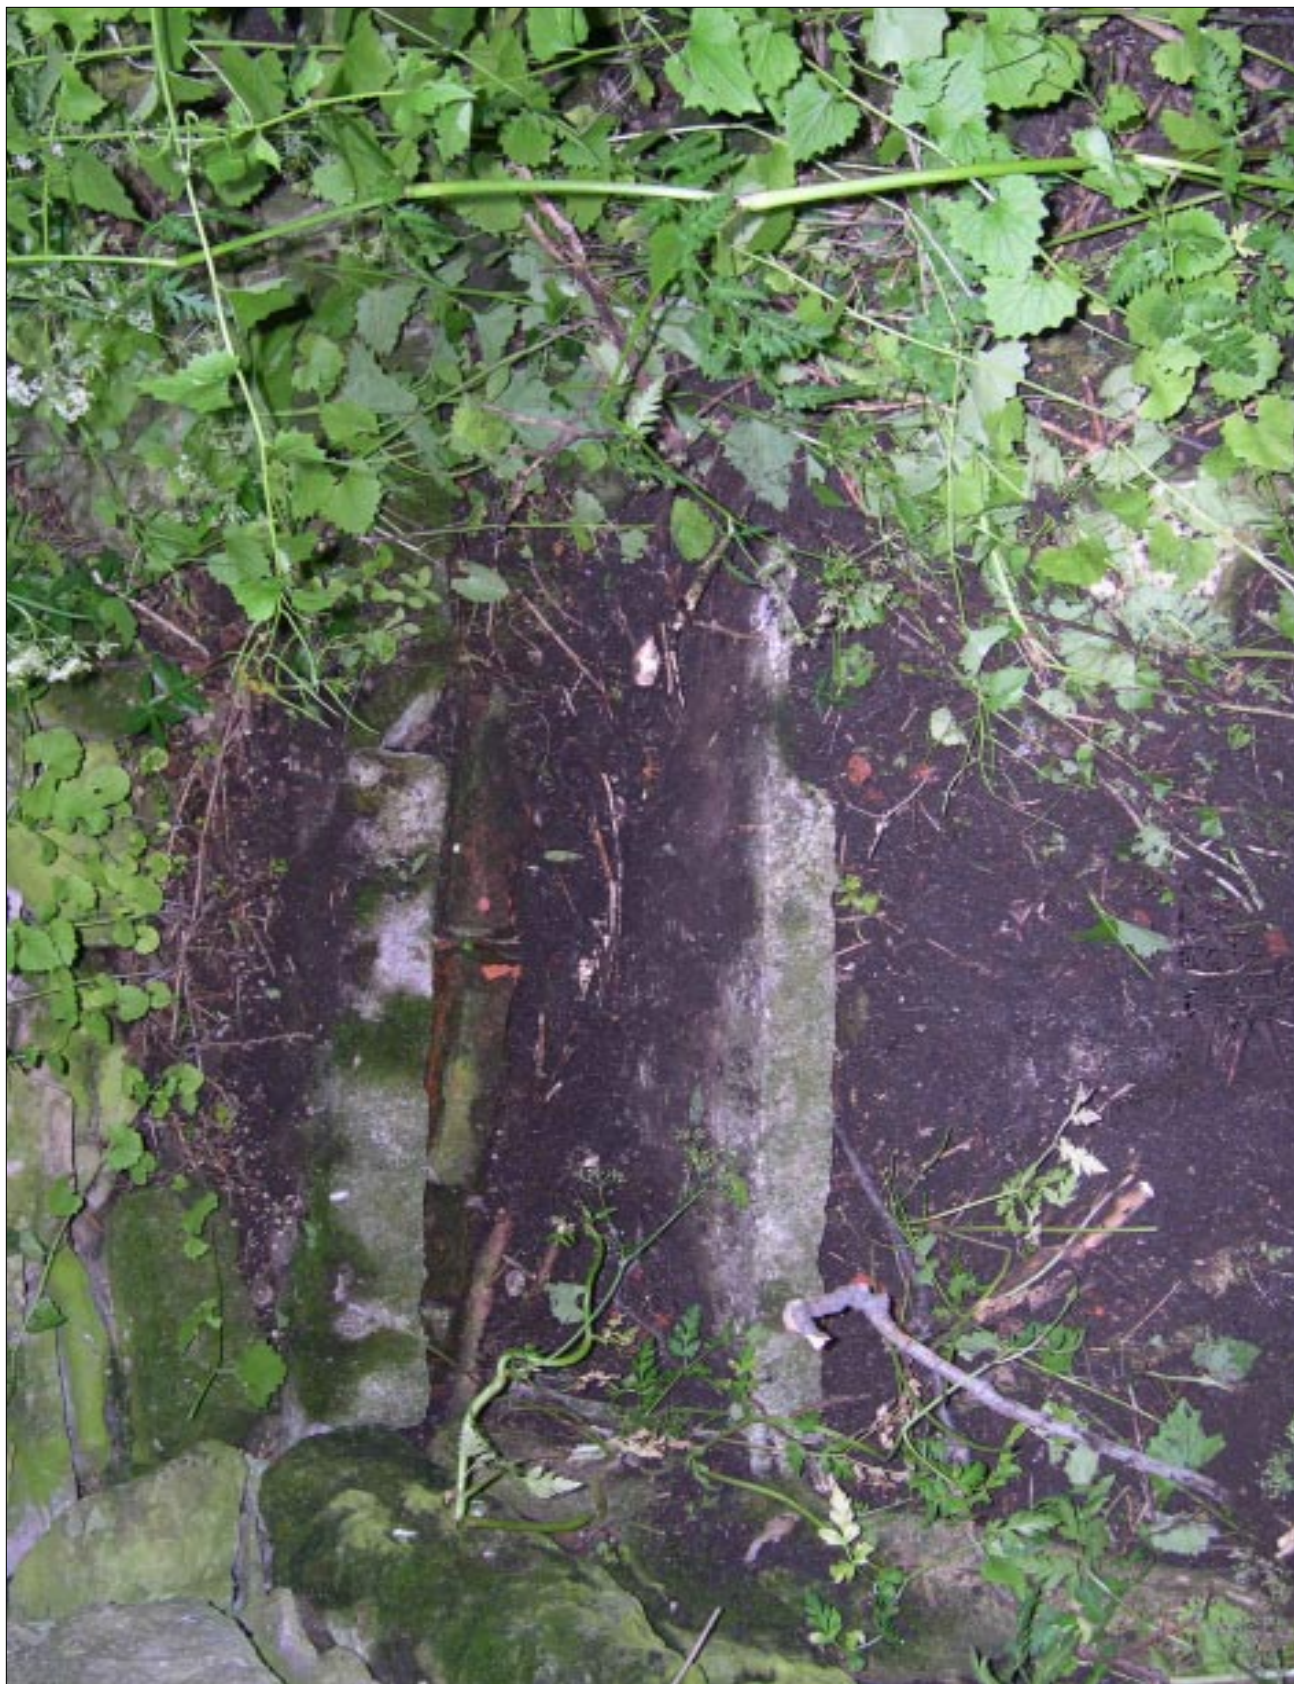
*Image LH-9. Cellar stairs of Lincoln House; note cut stone steps underlain with layers of brick (May 29, 2004).*

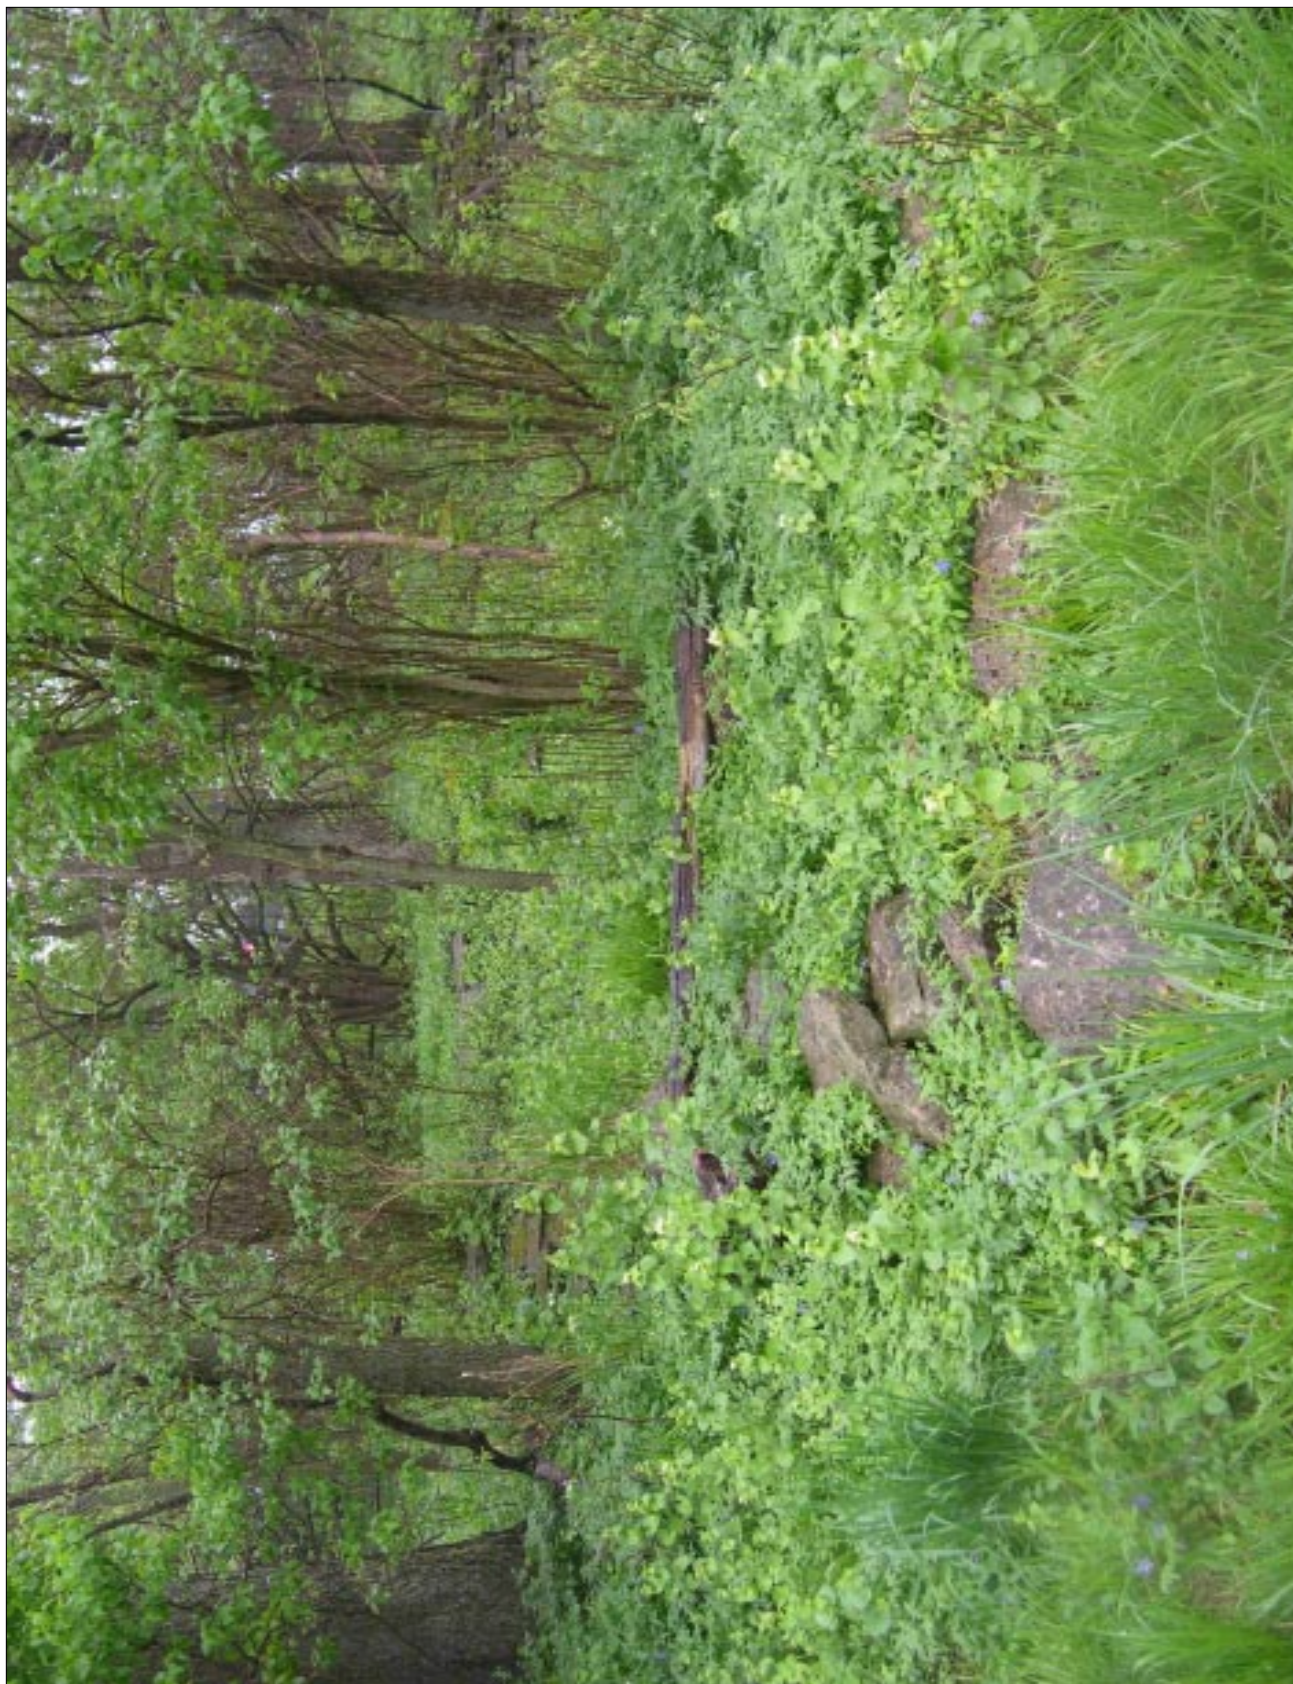
*Image LH-10. Foundation stones of Lincoln House along south side; note irregular shapes of limestone slabs (April 30, 2004).*

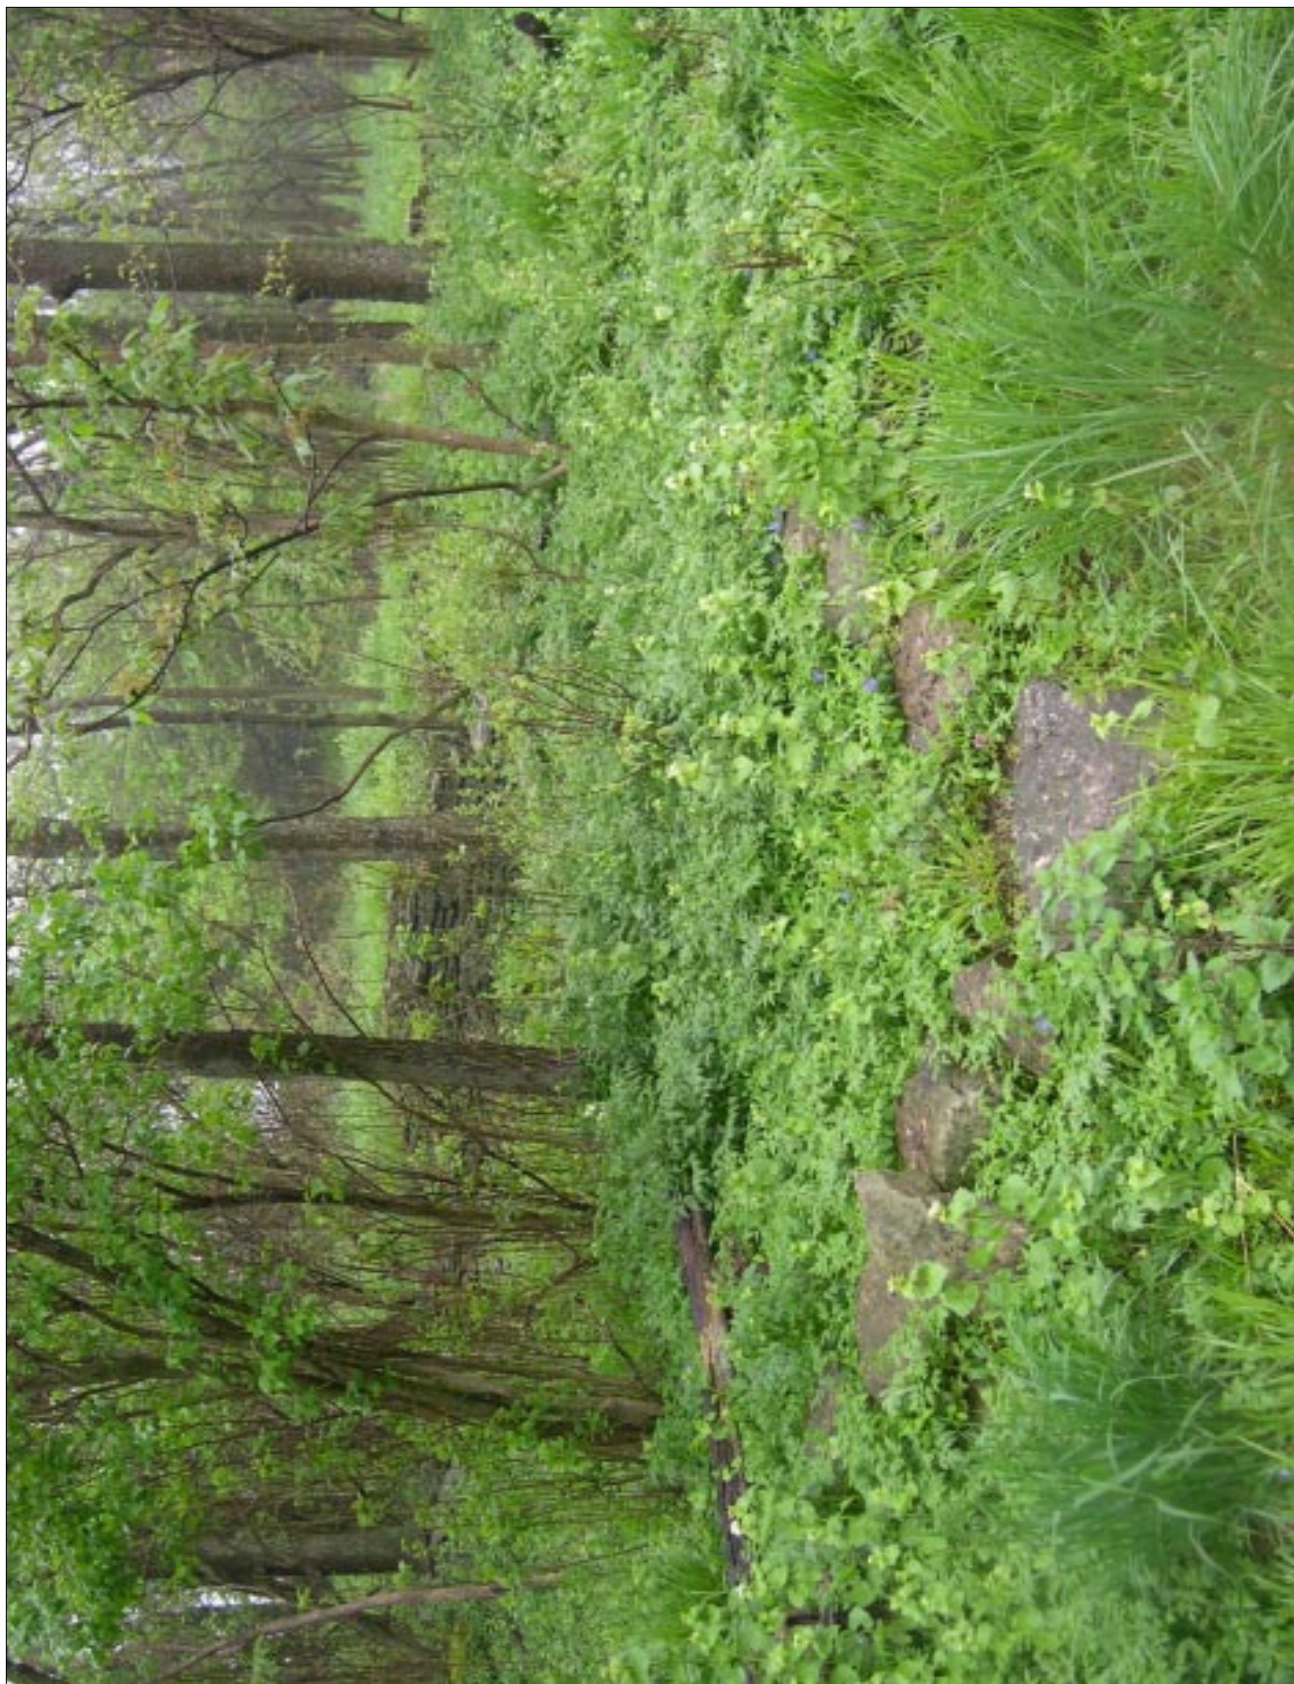
*Image LH-11. Foundation stones of Lincoln House at southern corner; cellar wall at upper left and position of presumed kitchen at upper right (April 30, 2004).*

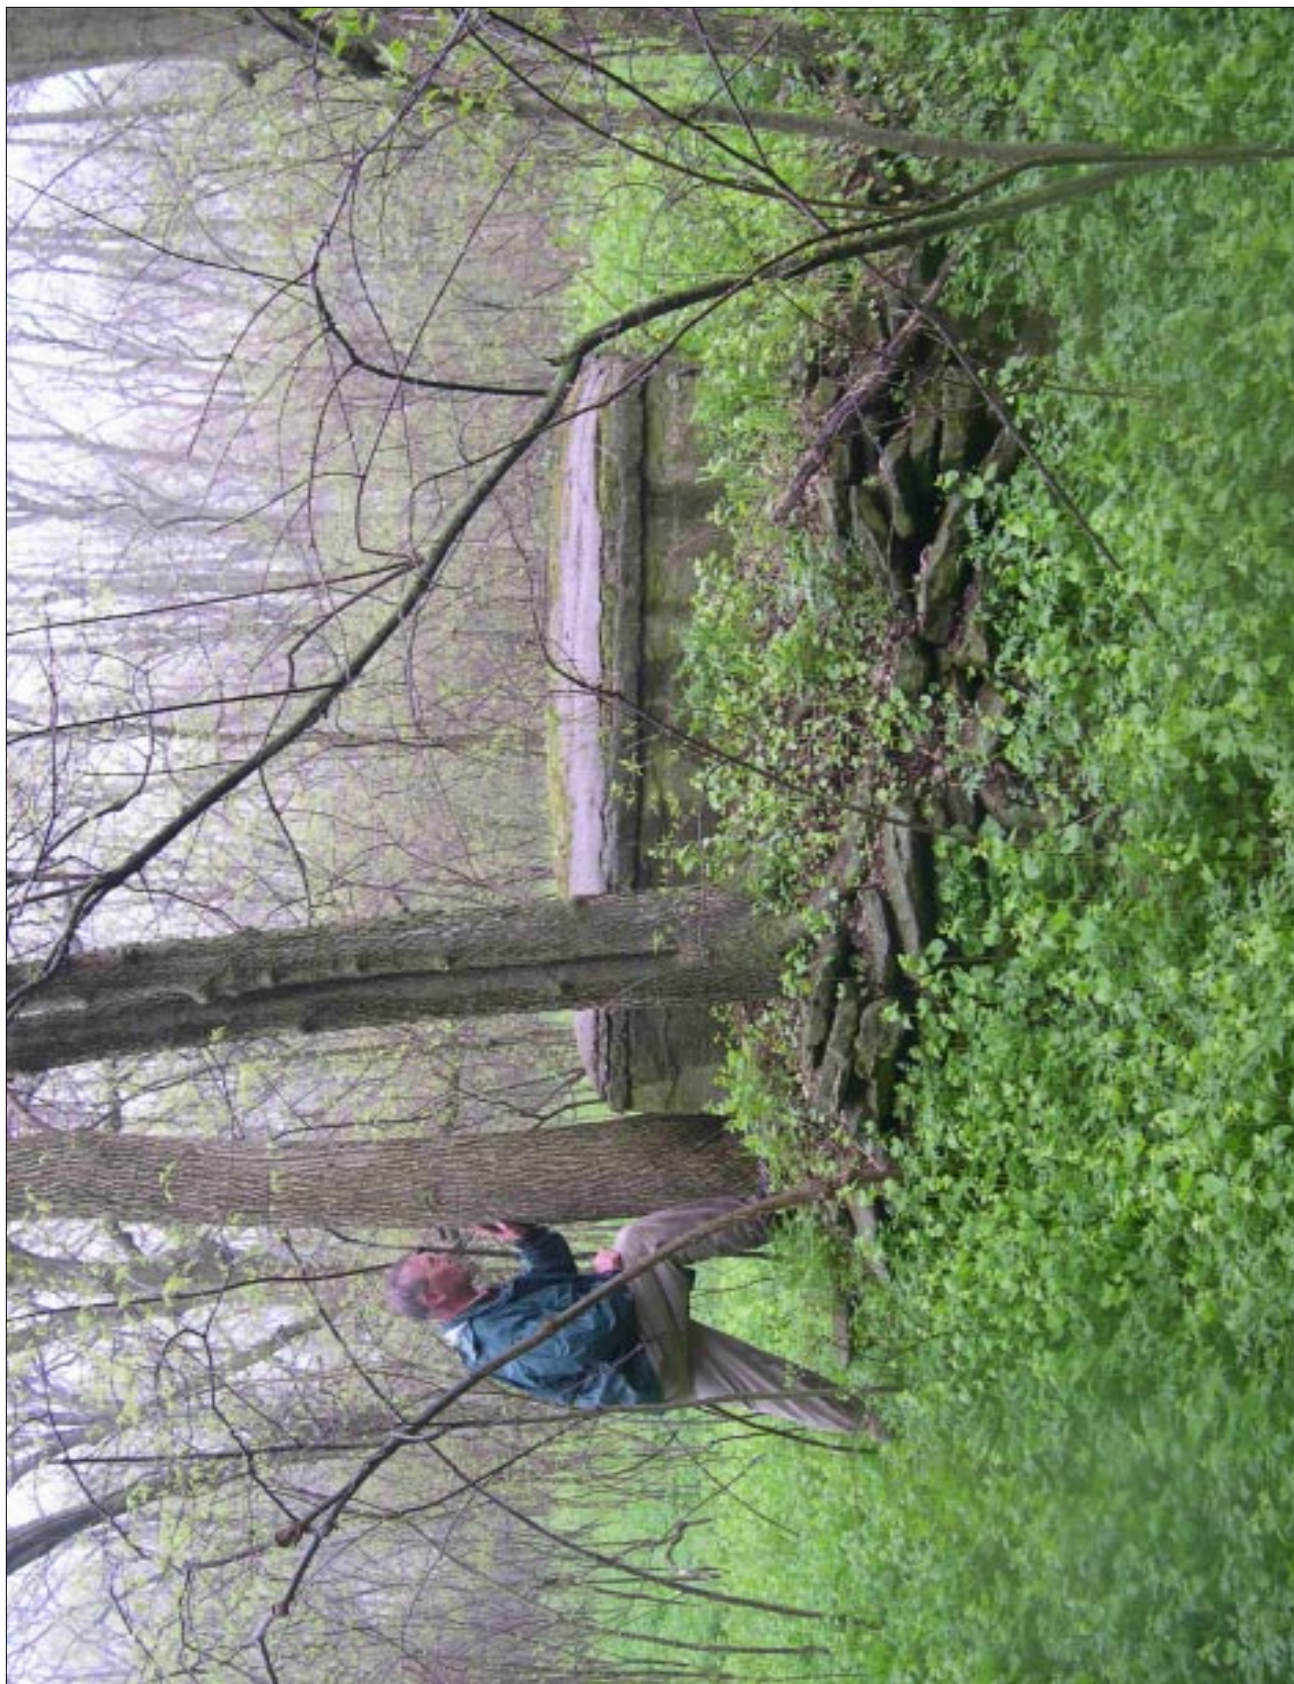
*Image IC-1. Isolated upground cistern (ca. 1910) located approximately 72 m southwest of Lincoln House; note perimeter wall of limestone slabs (April 30, 2004).*

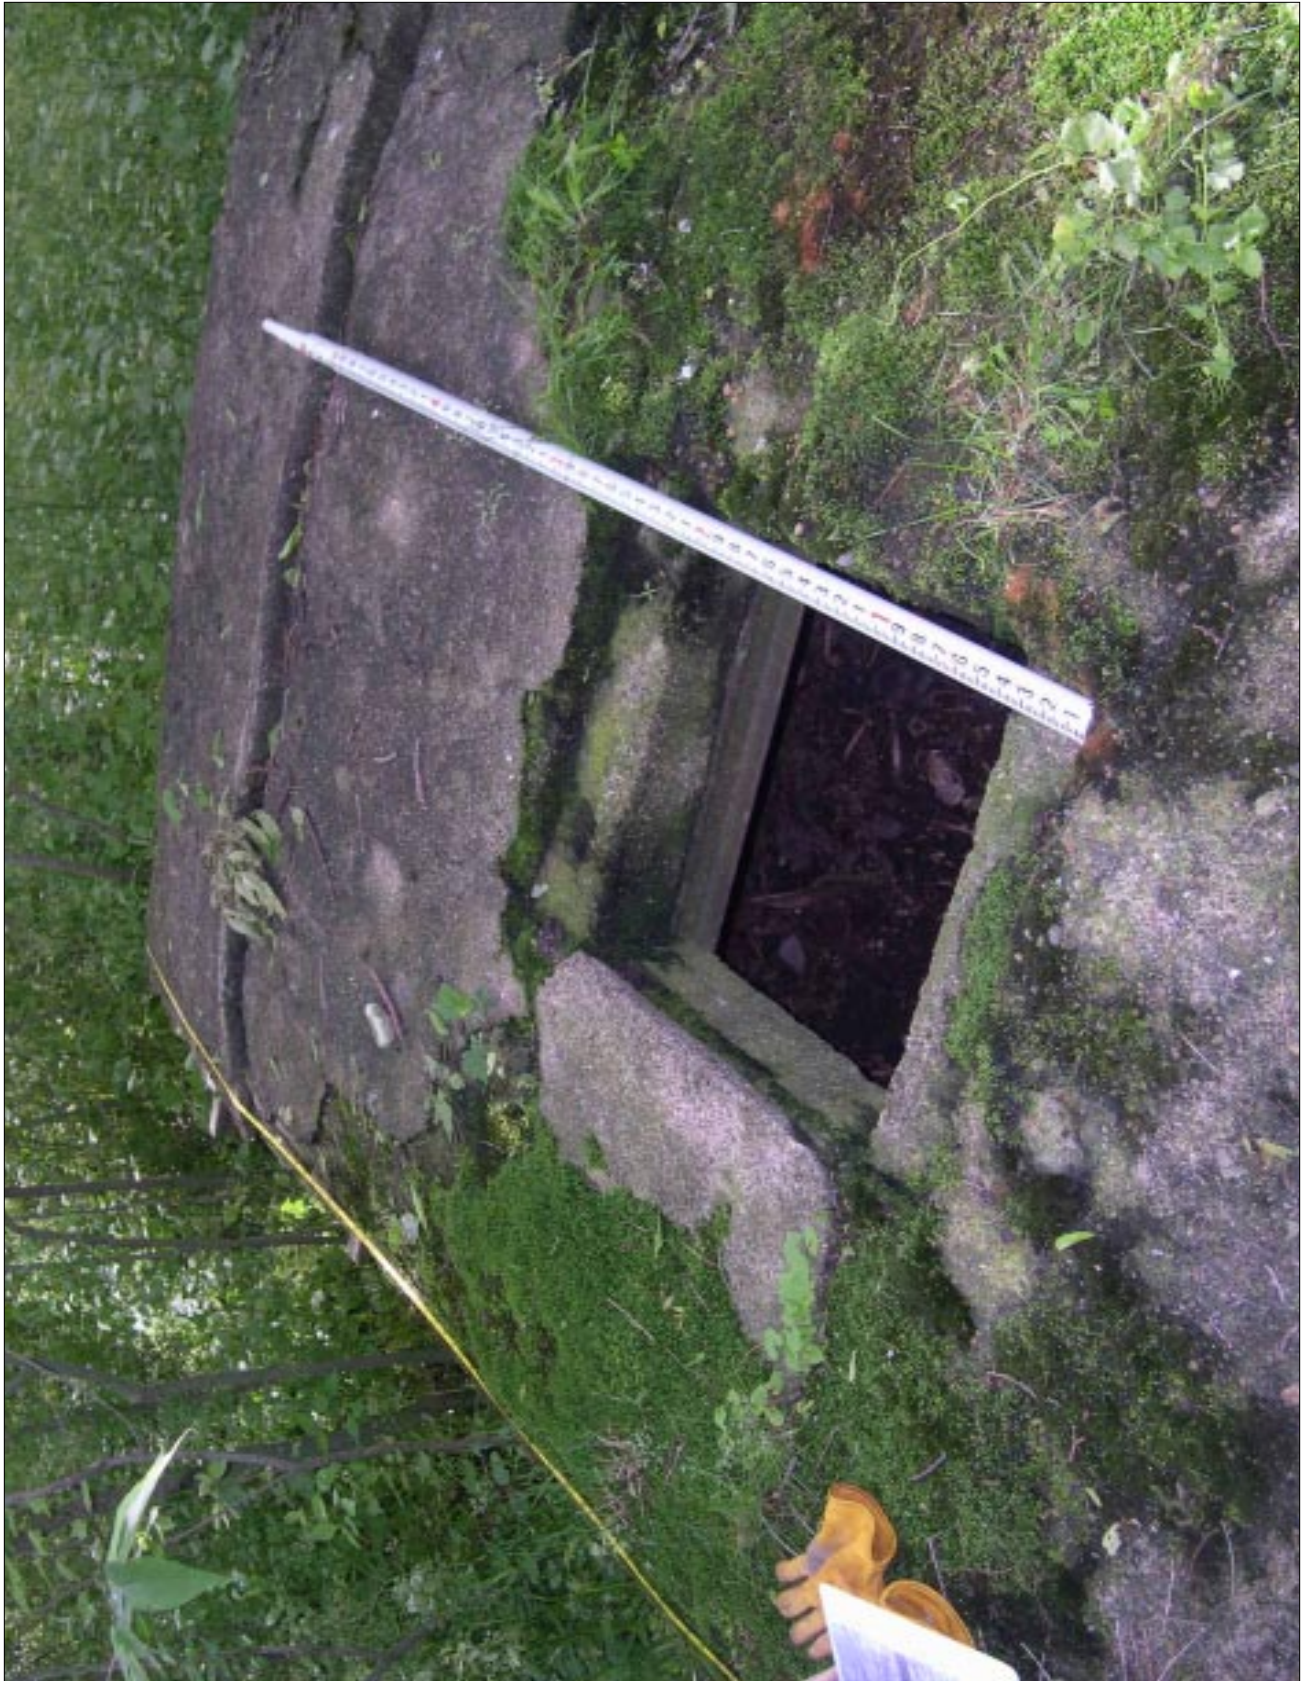
*Image IC-2. Cap of isolated cistern viewed toward the west, showing rectangular opening; stadia pole marked in feet and tenths (May 29, 2004).*

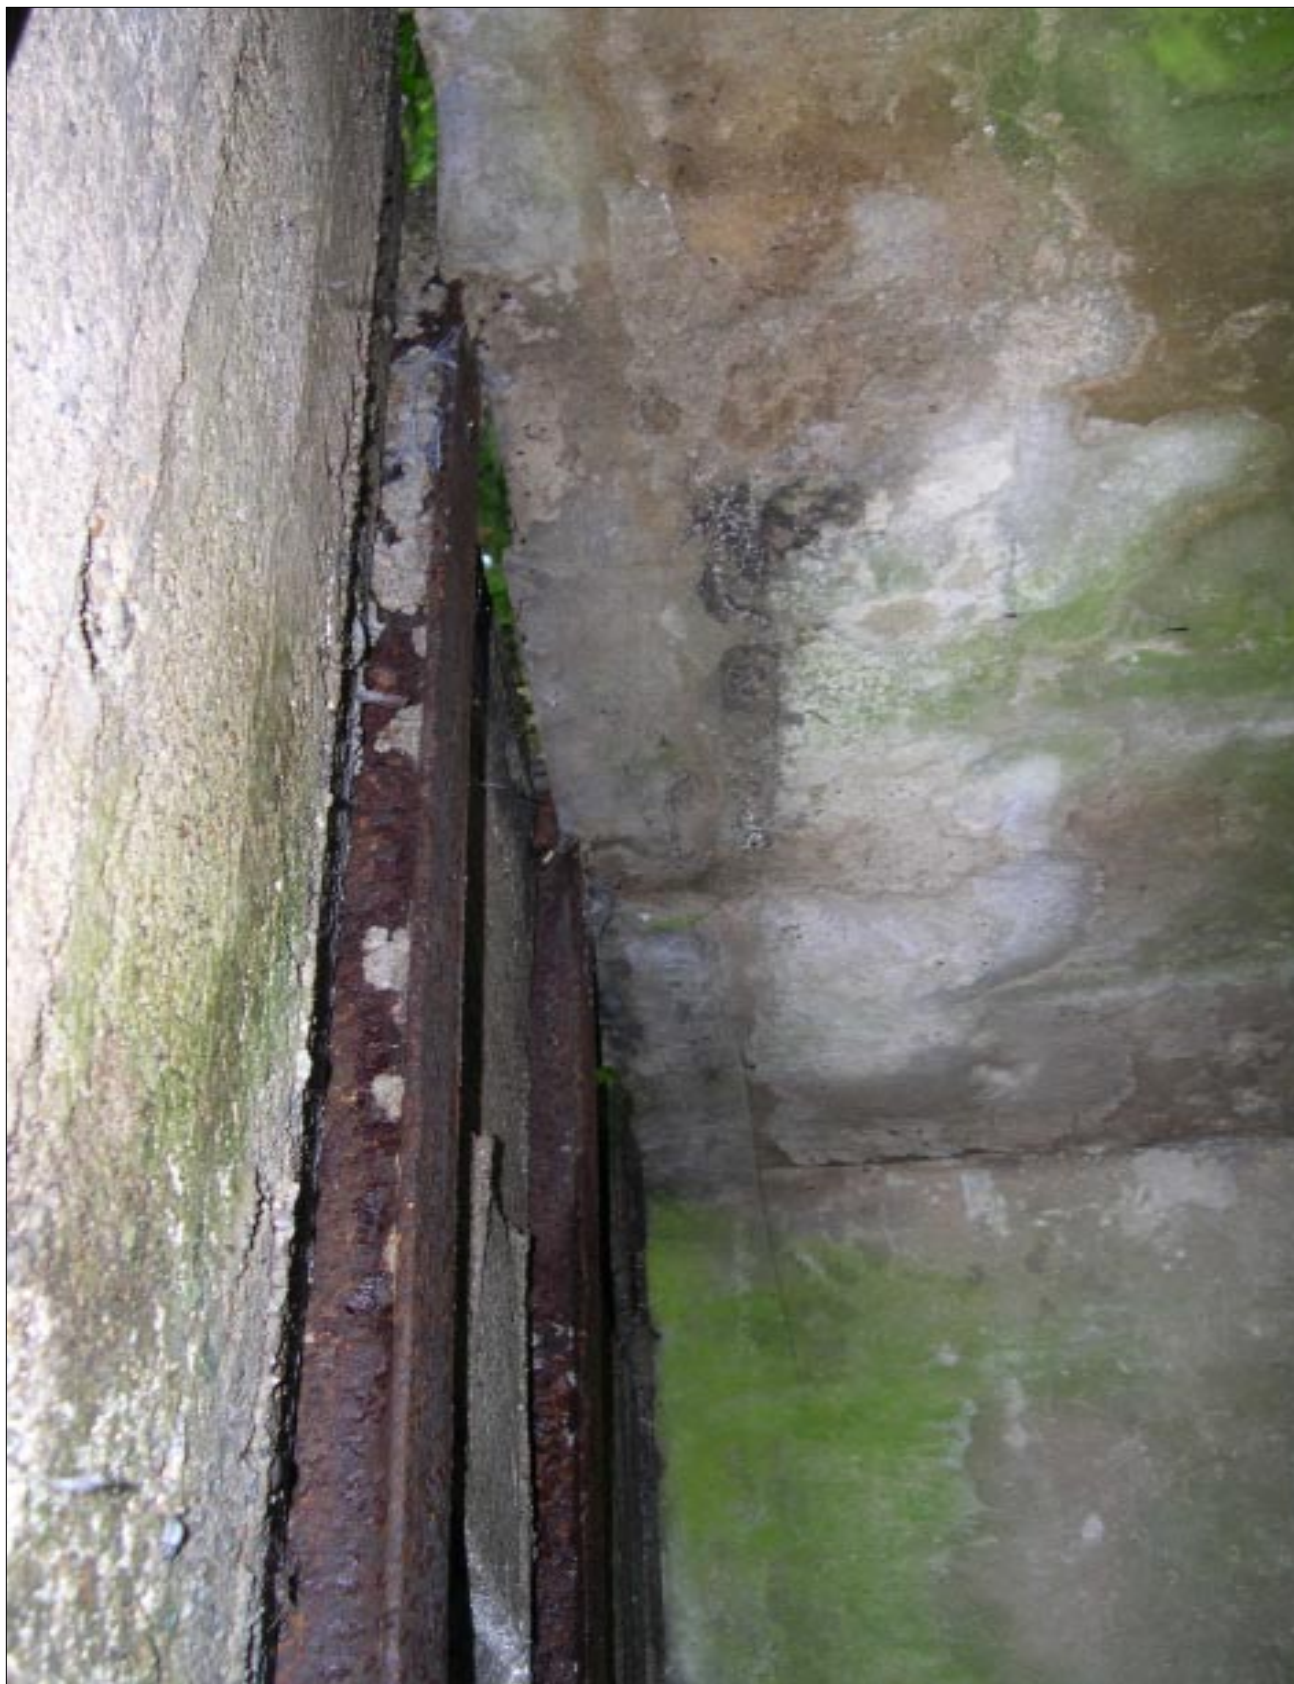
*Image IC-3. Interior view of cistern, showing concrete walls and cap which is reinforced with narrow-gauge railroad rails (May 29, 2004).*

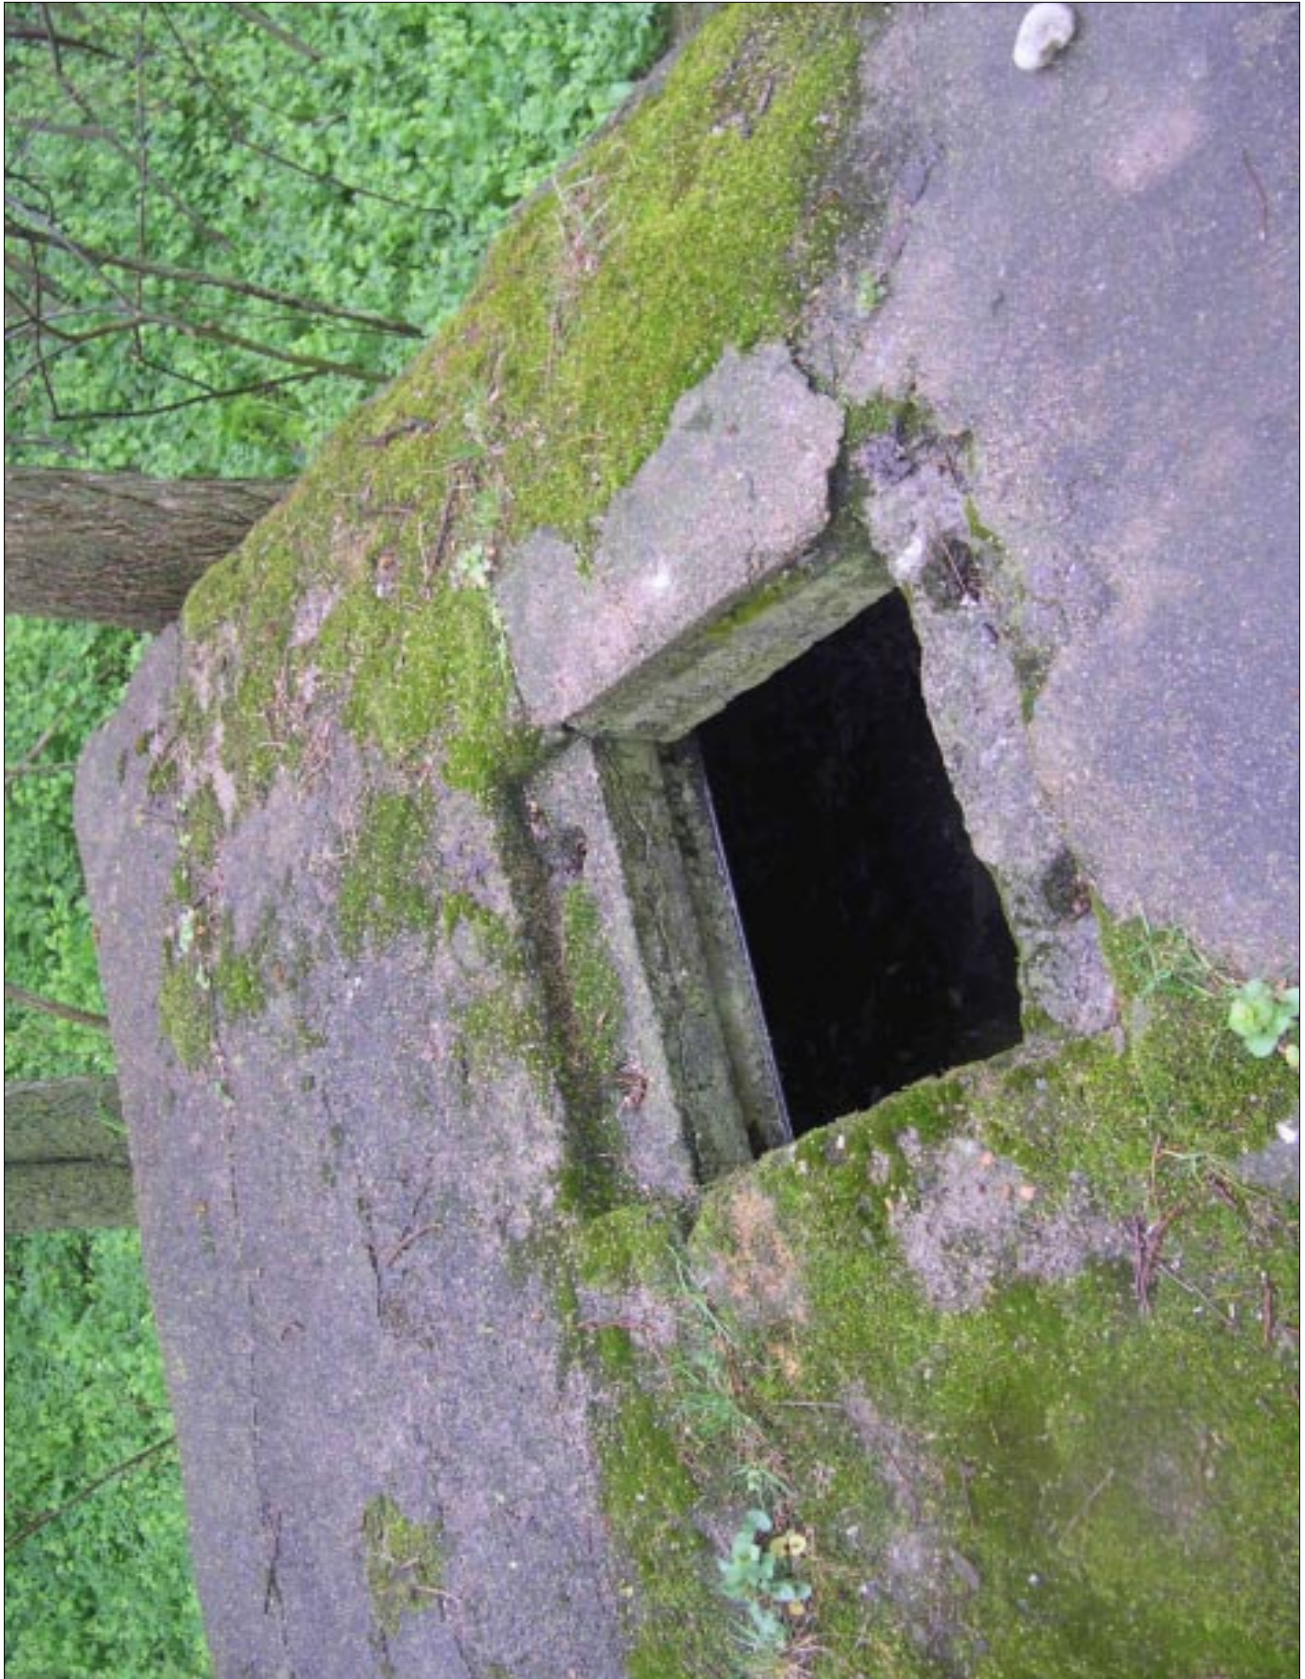
*Image IC-4. Cap of isolated cistern viewed toward the east; date "1910" etched in concrete is poorly visible at upper left (April 30, 2004).*

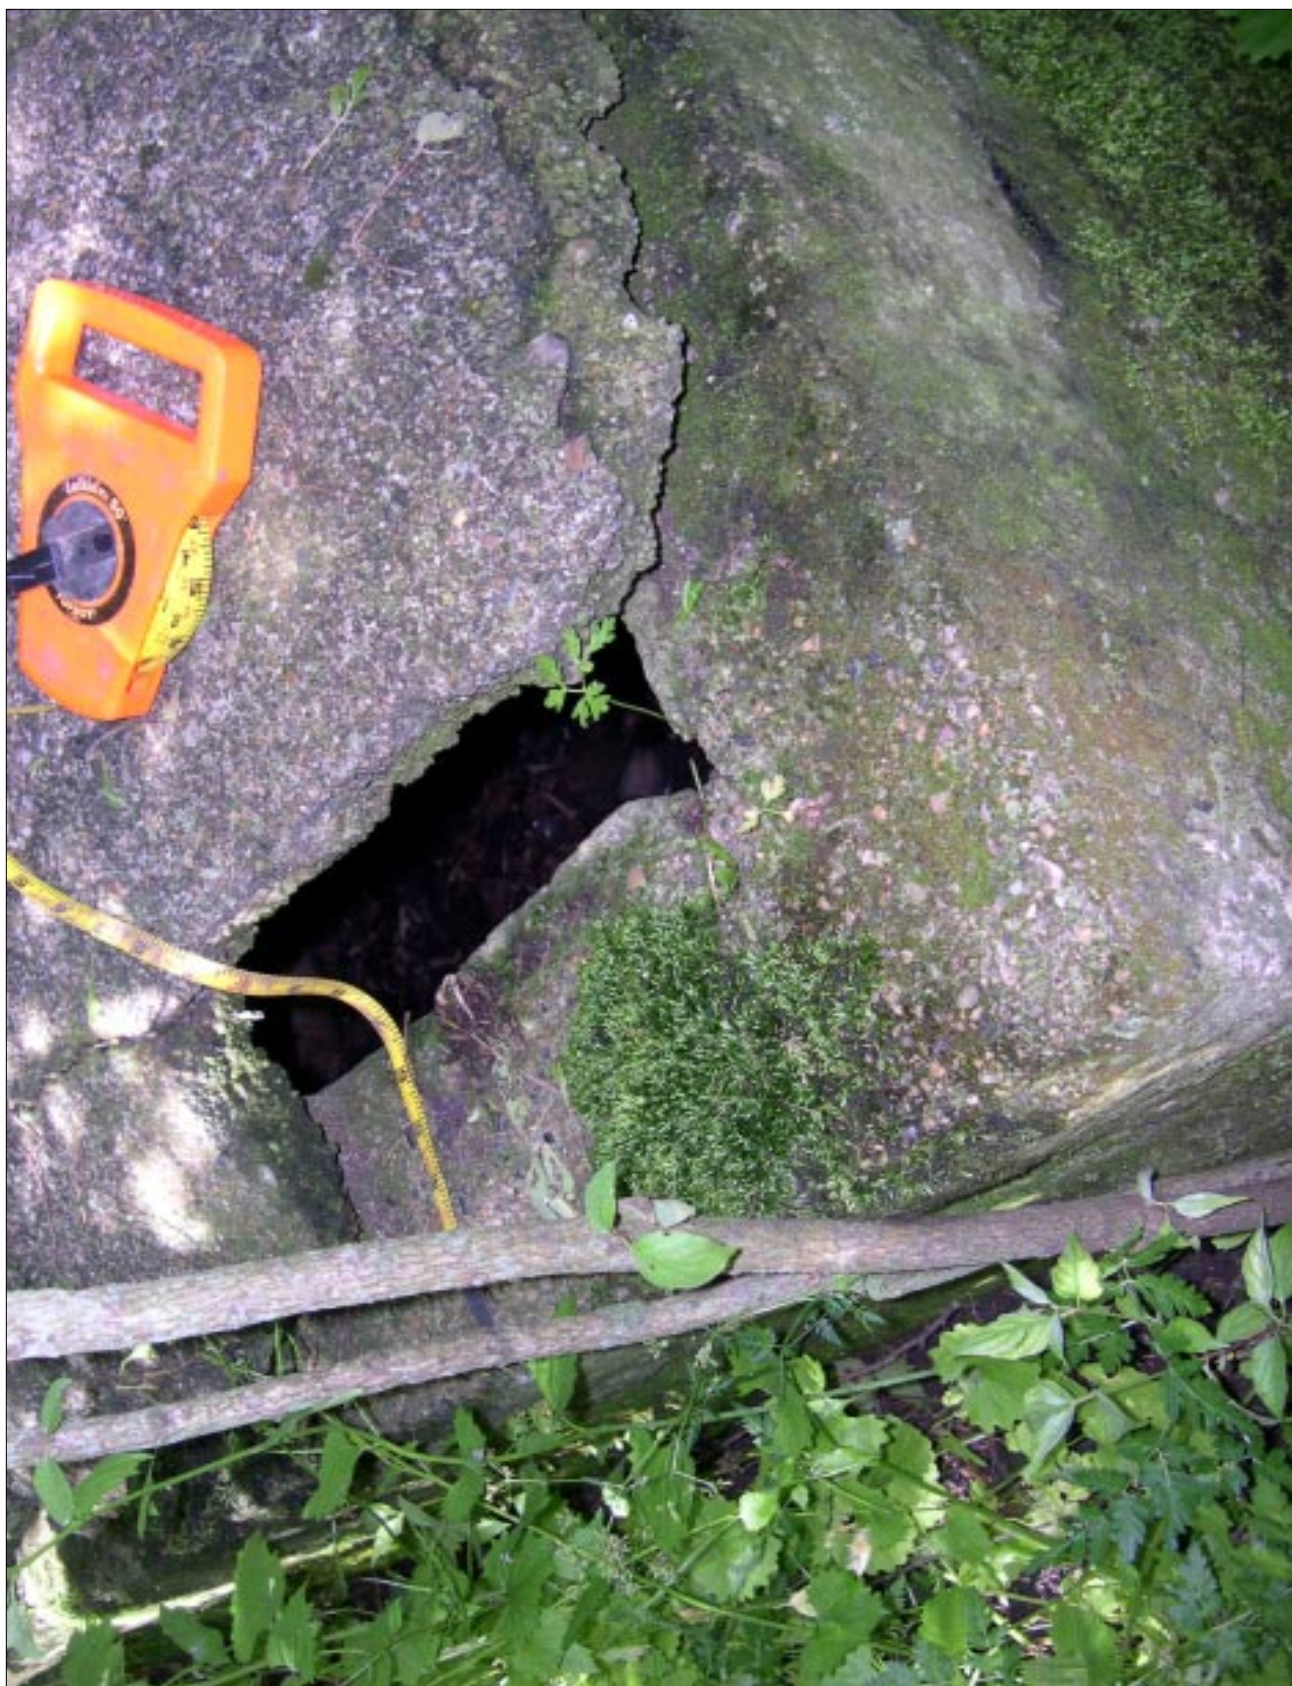
*Image IC-5. Broken cap at east corner of isolated cistern, showing interior and thickness of concrete walls; tape measure marked in feet and tenths (May 29, 2004).*

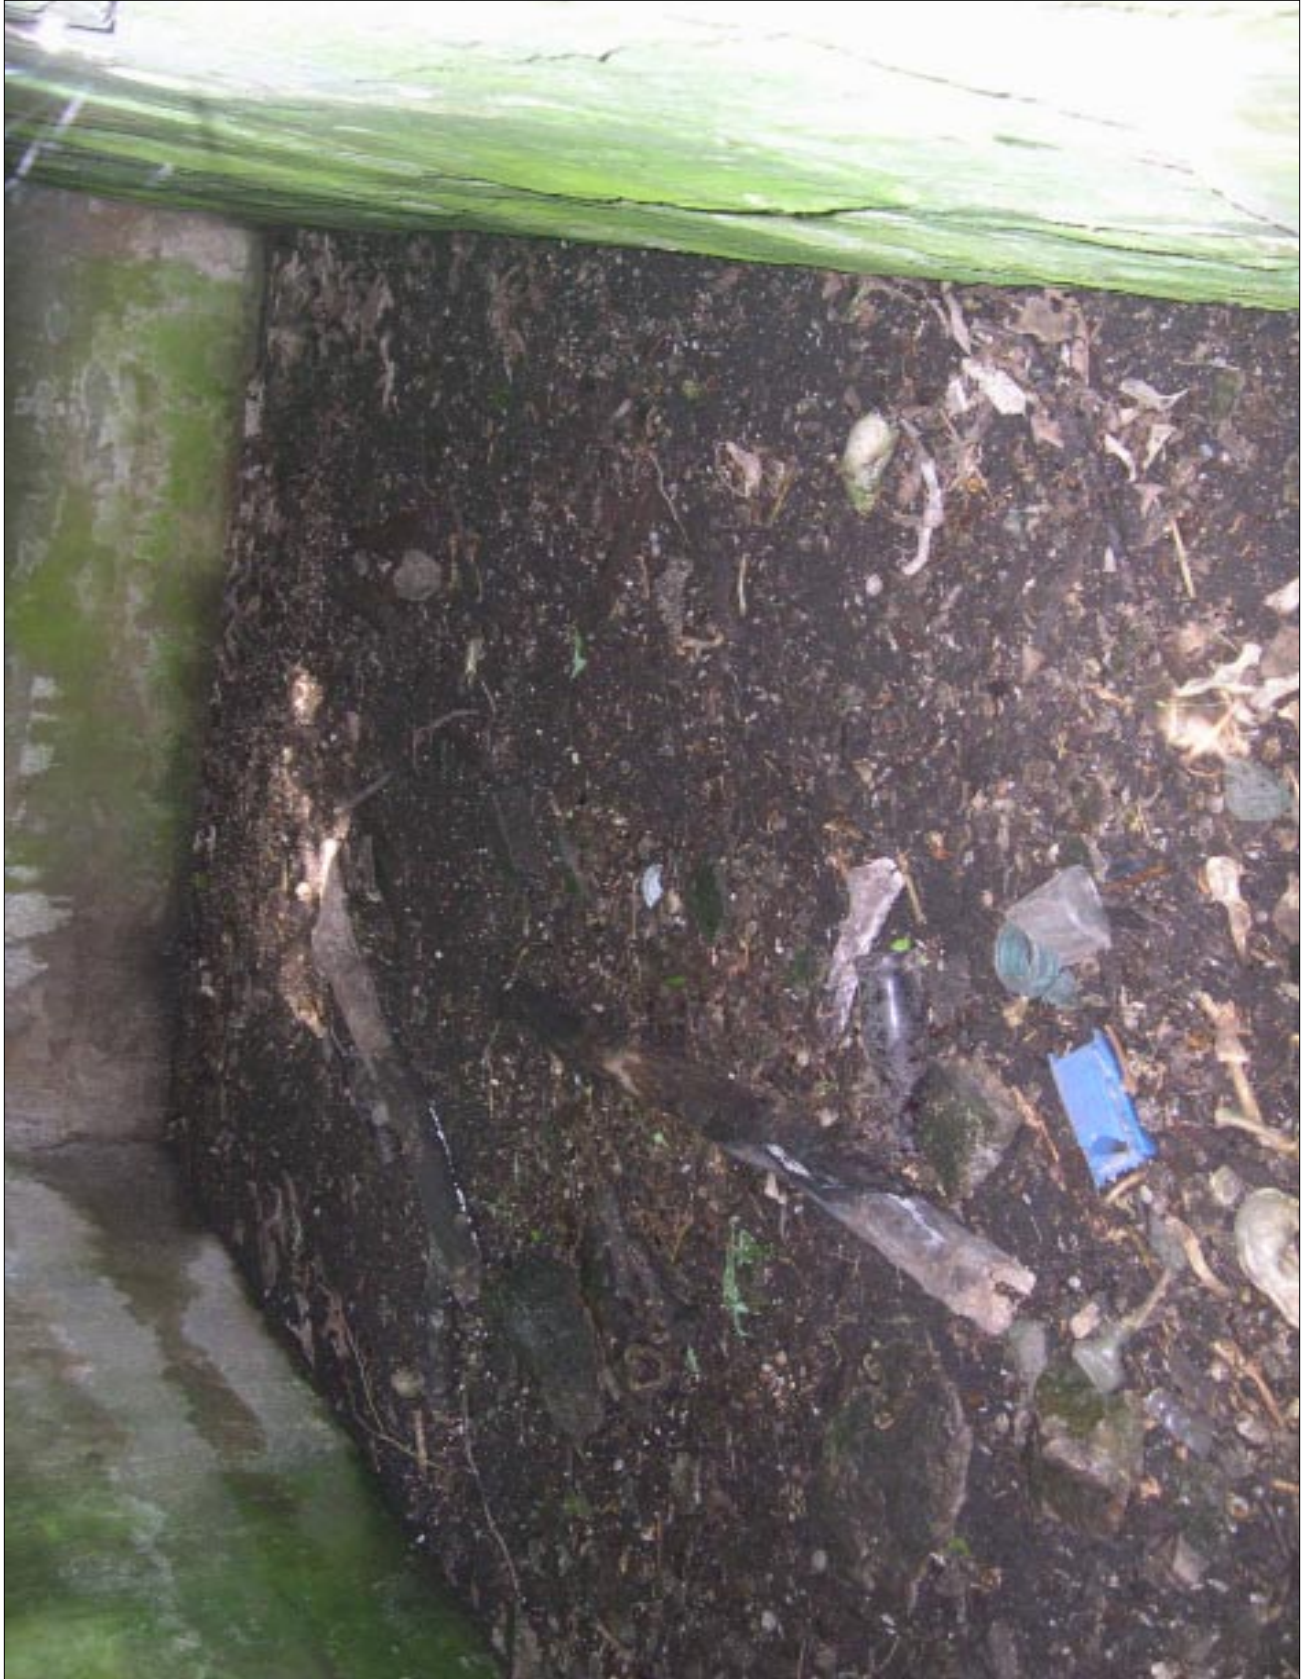
*Image IC-6. Interior of isolated cistern from east corner; cistern depth approximately 1.4 m (May 29, 2004).*
